# Manhole Inspection Summary

Manhole # S29A\_\_106MH

Insp Date: **5/5/09 9:56 AM**

**Location** Address: **700 MURPHY LN**

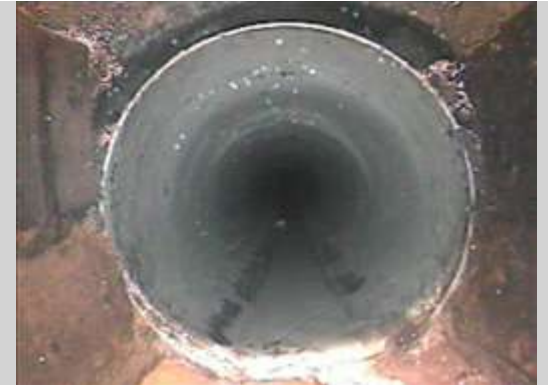
12 O'Clock Outflow

8 in. Circular Gravity Sewer  
Pipe Out @ 12 O'Clock

Pipe Height: (in.) Direct  
Pipe Material: **PVC** ☐ Pipe Lined  
Invert Depth: **9.70** (ft.) Flow Characteristics: **Slow**  
Deposits: ☒ None ☐ Mud ☐ Sludge ☐ Debris ☐ Grease  
Silt Depth: (in.) Deposits Extent:  
Infiltration: **None** Pipe Seal Cond: **Sound**

Drop: **None**

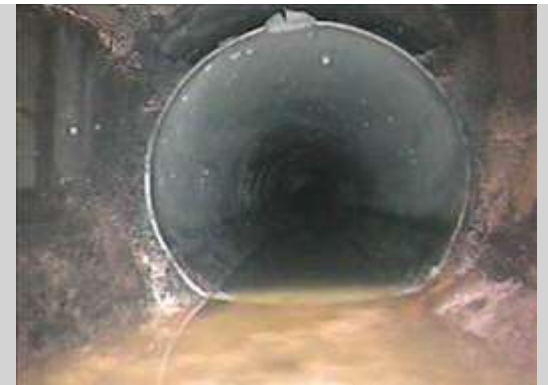
6 O'Clock Inflow

8 in. Circular Gravity Sewer  
Pipe In @ 6 O'Clock

Pipe Height: (in.) Direct  
Pipe Material: **PVC** ☐ Pipe Lined  
Invert Depth: **9.80** (ft.) Flow Characteristics: **Slow**  
Deposits: ☒ None ☐ Mud ☐ Sludge ☐ Debris ☐ Grease  
Silt Depth: (in.) Deposits Extent:  
Infiltration: **None** Pipe Seal Cond: **Sound**

Drop: **None**
